Thomas L. Davis
Consulting Geologist
592 Poli Street
Ventura, CA 93001
(805) 653-2435 Fax (805) 653-2459
davnamthom@aol.com
www.thomasldavisgeologist.com

RE: Dunsmore Debris Dam and Basin, Los Angeles County, California

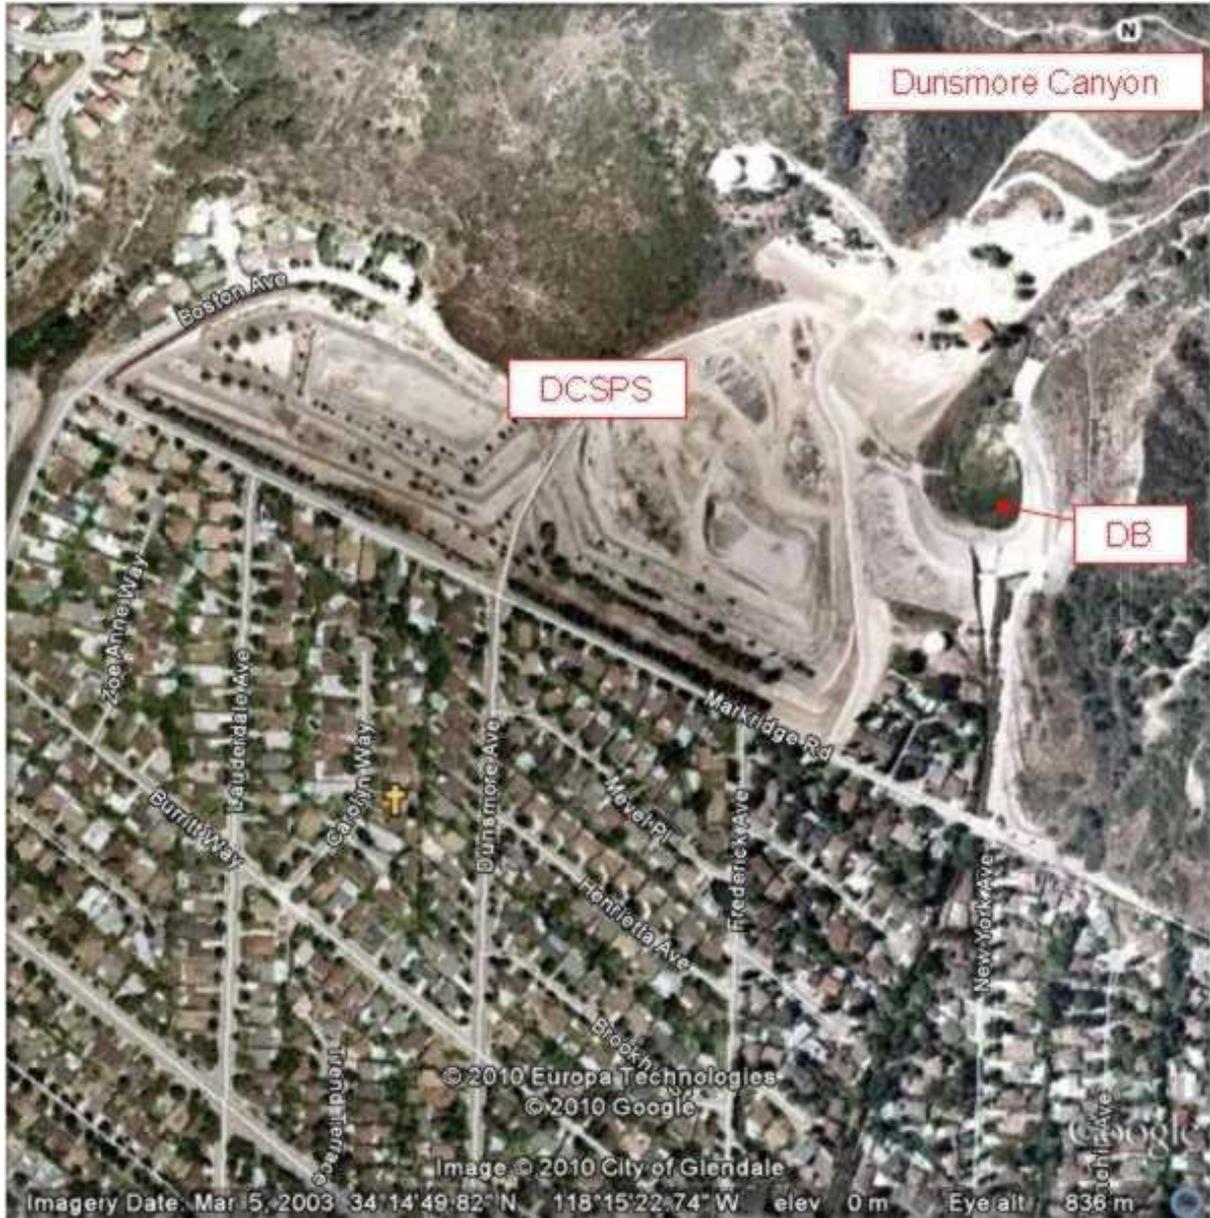
Figure 2. Dunsmore Canyon sediment placement site (DCSPS) and debris basin (DB) located at the mouth of Dunsmore Canyon, 2003 image. An extensive residential area of north Glendale is located downslope of the sediment placement site and debris basin.

The SPS occupies most of the canyon mouth both linearly and aerally, and the debris dam and basin occupy only a fraction of the eastern portion of the canyon (Figures 2 & 3). The combined SPS, debris dam, and basin span the entire mouth of Dunsmore canyon and any flow from the canyon, whether water or debris flows, will encounter one or more of these structures downstream. Combined, these effectively create one man-made structure across the entire mouth of Dunsmore Canyon that is much larger than the existing debris dam.

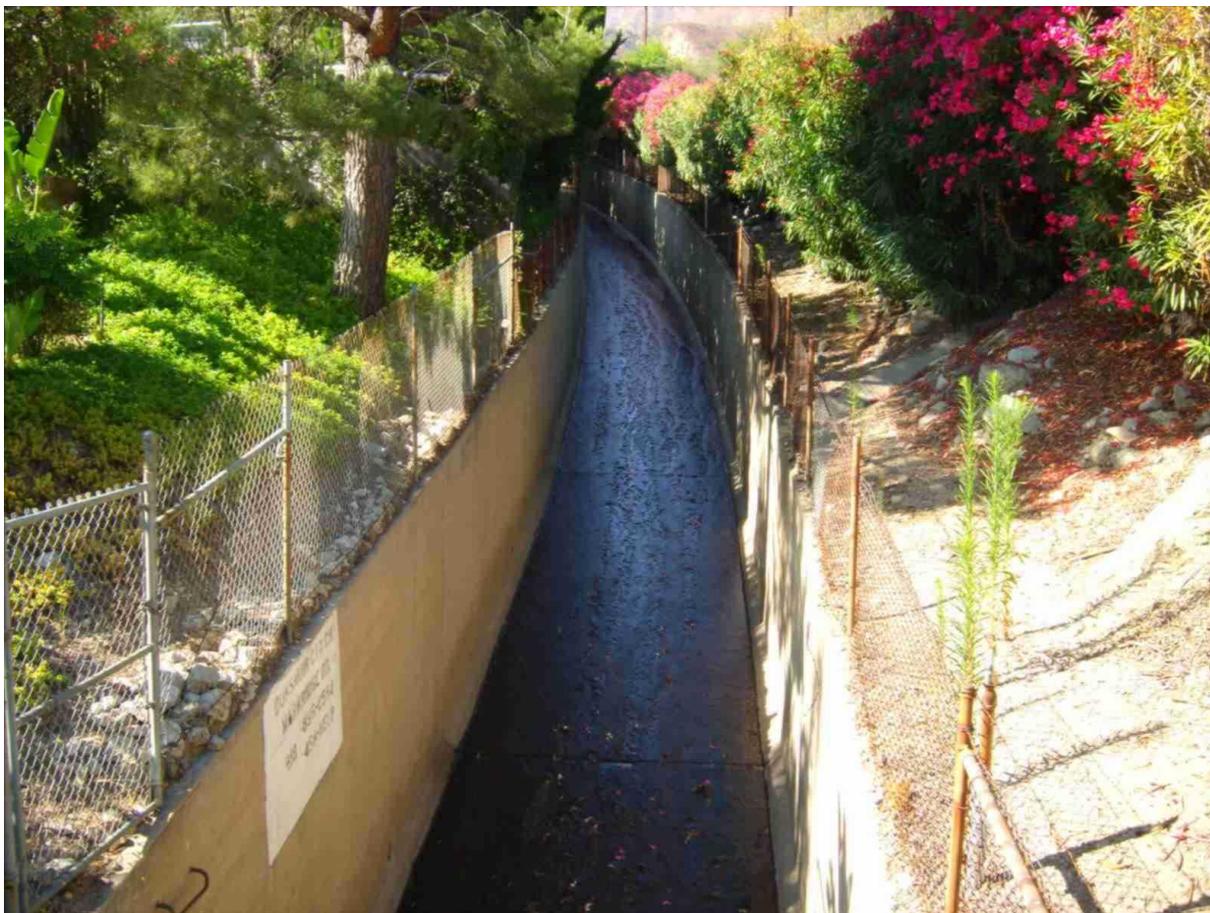
Figure 4. Outlet channel for Dunsmore debris basin (debris dam and basin are located behind vegetation). Looking north from point where channel passes under Markridge Road: a potential debris-flow spreading point if basin fills and excess flow continues into channel.

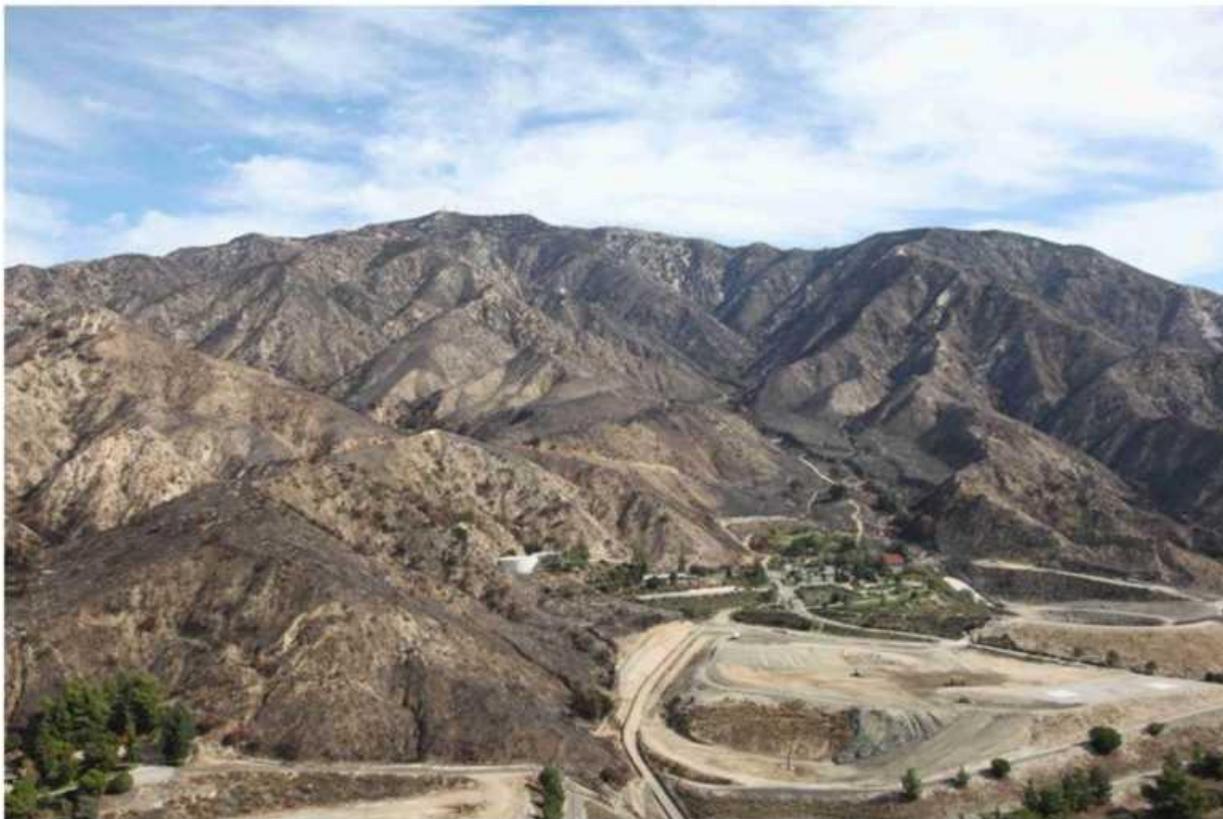
Figure 7. Dunsmore Canyon, San Gabriel Mtns. Photo taken shortly after the August, 2009 Station Fire; view north. The debris basin located on far right has a maximum capacity of 102,700 cu-yds. Los Angeles County Department of Public Work's sediment placement site is in lower part of photo.

The increased debris flow risk to Dunsmore Canyon, and the entire Crescenta Valley, from the impact of the Station Fire will remain until the vegetation cover returns to the mountains -at least several years (Figure 7). The upcoming rainy season will be the second since the Station Fire, and the climatic forecast is for dryer conditions in southern California (La Nina year). Short term climatic forecasts can have local variations. Overall 1934 was not a wet year (El Nino) despite the extreme local rainfall amounts that initiated the 1934 New Year's Day debris flows. During the next few years the probability of a 1934-type debris-flow event is low but if it were to recur the impact to public safety will be extreme. It is my belief that the Dunsmore SPS may add additional risk to a flood control system that was not designed to handle a repeat of a 1934-type event.
